Property Inspection Service

PROFESSIONAL BUILDING INSPECTION

1120 Pomeroy Avenue, Santa Clara

September 14, 2020

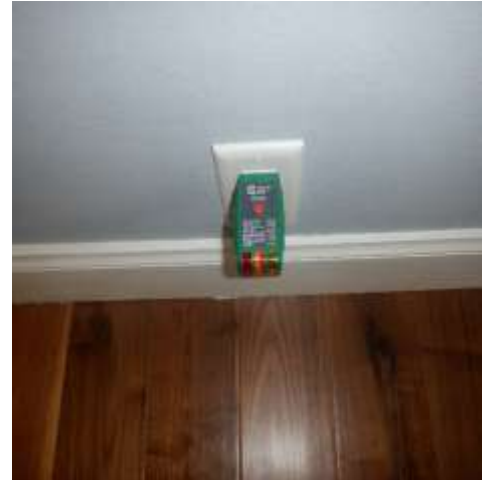
C. The duplex outlets at the rear master bedroom wall (SEE PHOTO), patio, and dining area are not grounded, therefore, do not provide adequate user protection for appliances using a three-prong plug. It is recommended that a competent electrical contractor be consulted for recommendations and corrective work. Please be advised that many non-code complying electrical conditions may be considered a potential fire hazard and/or threat to health and safety.

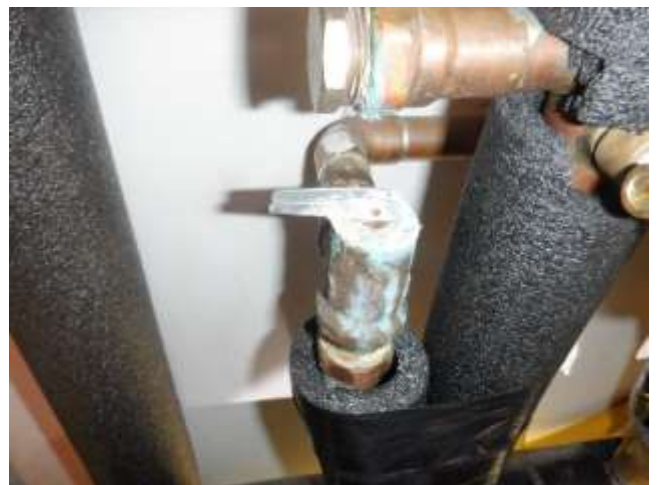
The domestic water piping is copper, all of which appears to be in serviceable condition with no signs of unusual or excessive deterioration. Our visual inspection and operation of several faucets suggests that volume and pressure are reasonable. There is evidence of minor corrosion at the water piping at the pressure relief valve at the water heater. This condition does not appear to compromise the serviceability of the piping at this time. (SEE PHOTO)
